ASPINOOK DAM

CT. 00539

PHASE I INSPECTION REPORT
NATIONAL DAM INSPECTION PROGRAM

NOVEMBER 1979

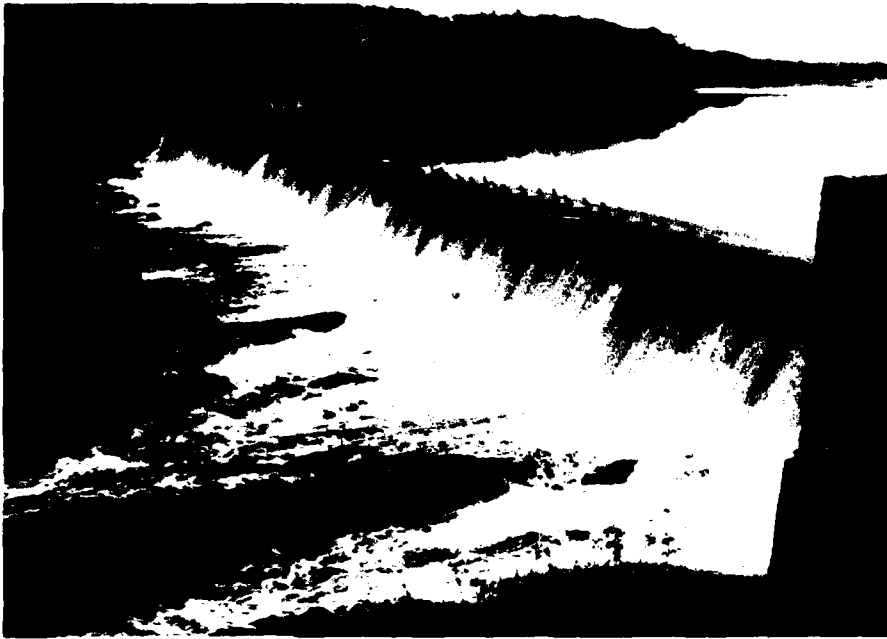
Overview from left abutment.

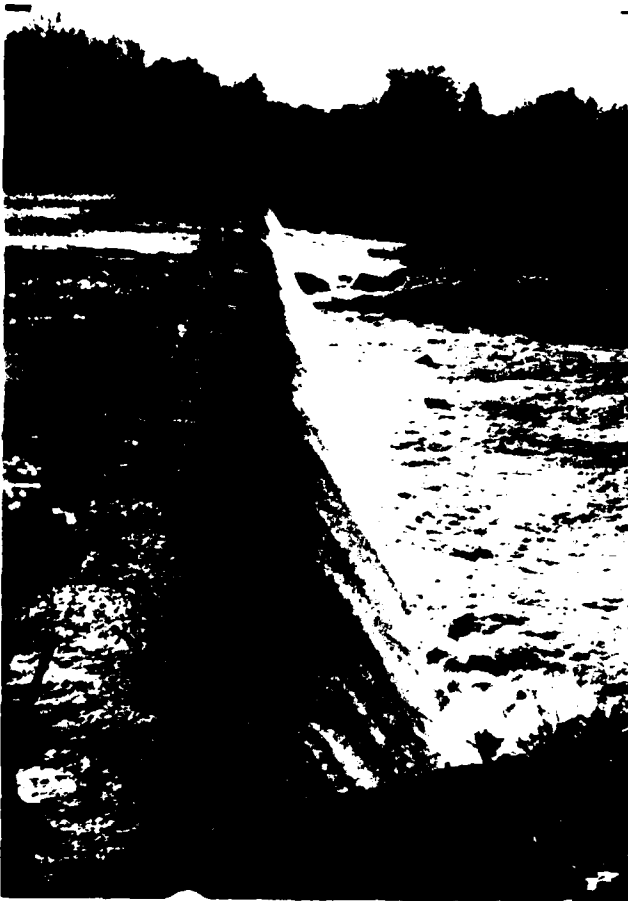
Overview from
right abutment.

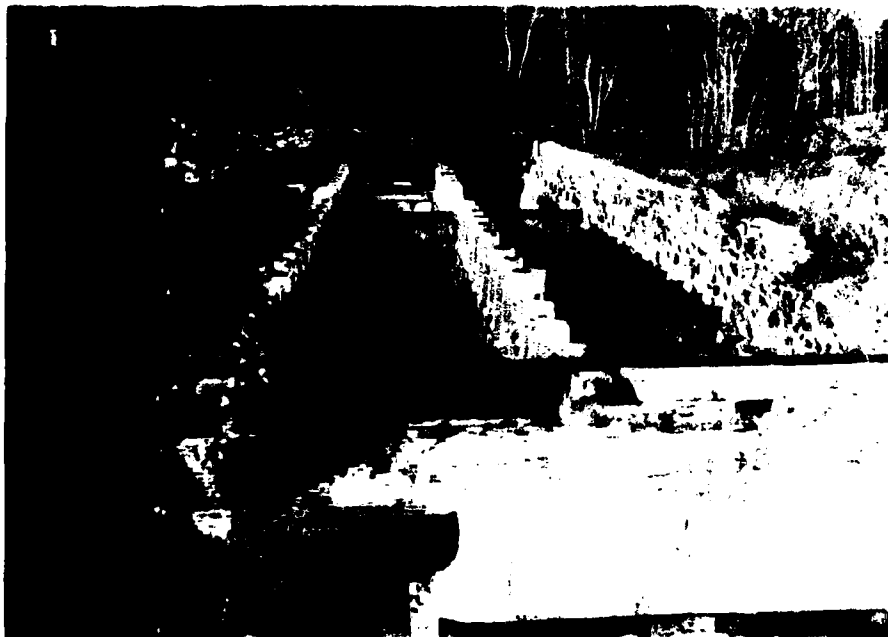
7. 36 in. dia. water pipe from forebay to plant (upper)
and 24 in. dia. pipe cut off (lower).
